# Every Home Inspection

Confidential - Property Inspection Report - Confidential

11 Hill Road, Yourtown, MN  
Inspection prepared for: Jane Doe  
Real Estate Agent: Mary Smith - Hometown Realty

Date of Inspection: 5/10/2014  
Age of Home: Built in 1990 Size: 3752 sq. ft.  
Weather: Partly cloudy

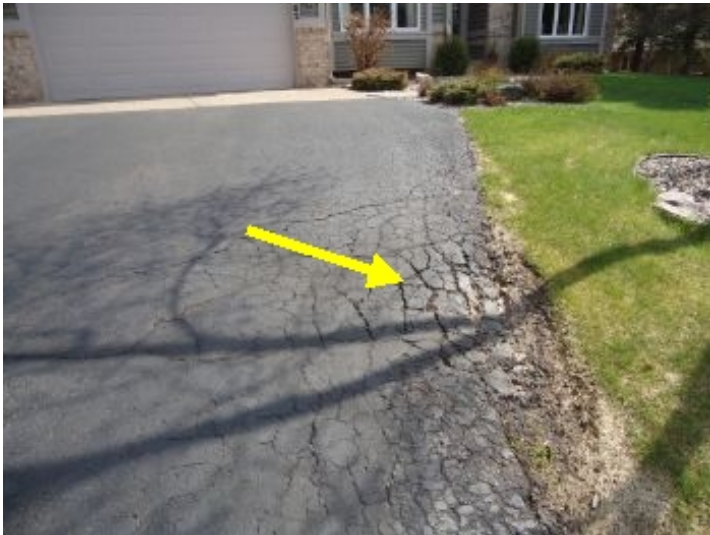
**Materials:** Asphalt some settling noted. Mostly cosmetic now but will continue to deteriorate with freeze thaw cycles and will eventually need replacement. See photo

will deteriorate further

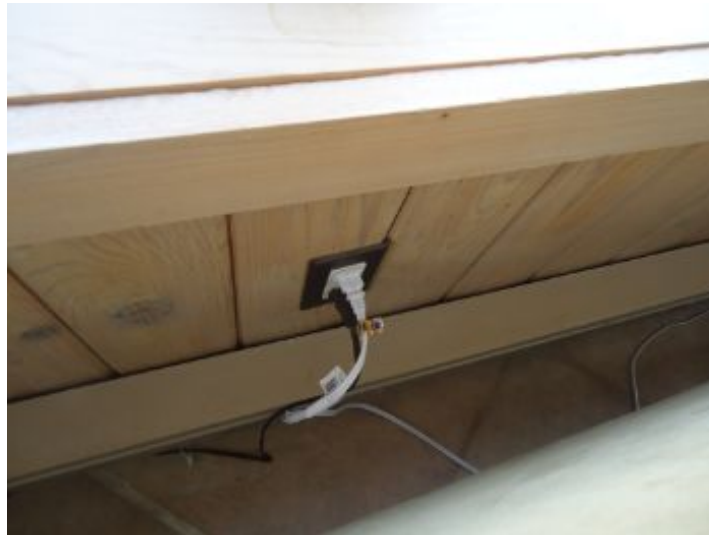
- There is an electrical outlet above baseboard heating. This is a fire hazard and should be remedied by a professional.

electrical cords too close to heater on porch

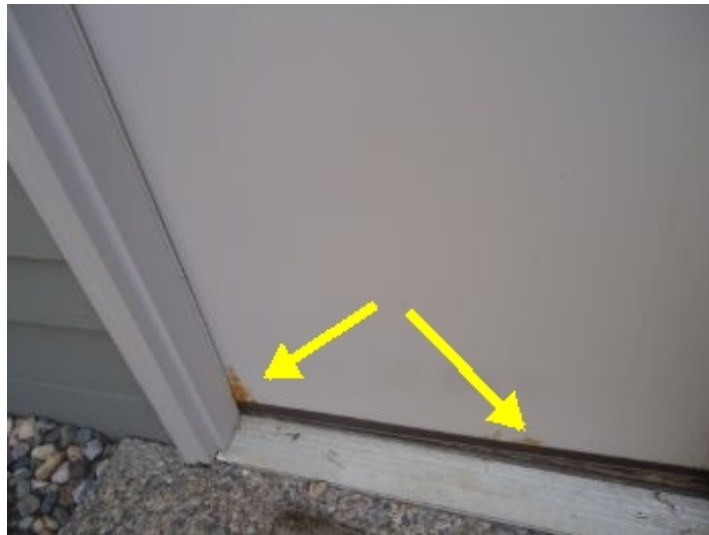
- Service door is rusting. Can be sanded, primed/painted with a rust preventitive but often the rust will return in time.
- Storm door latch needs repair or replacement

metal garage service door rusting

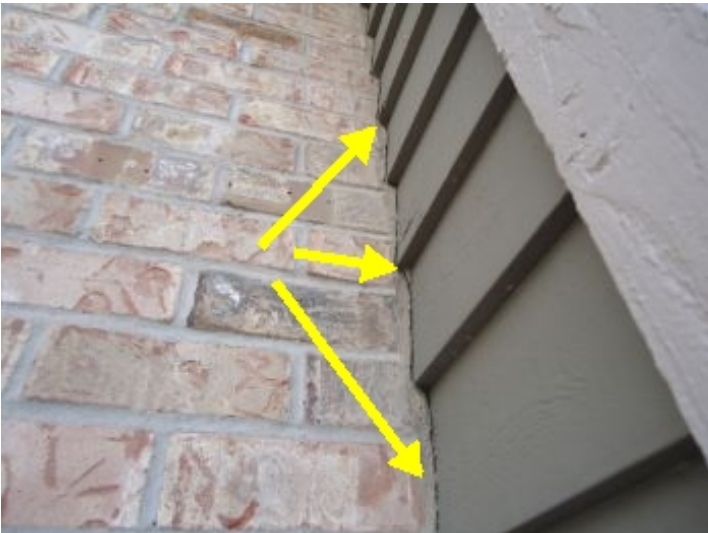
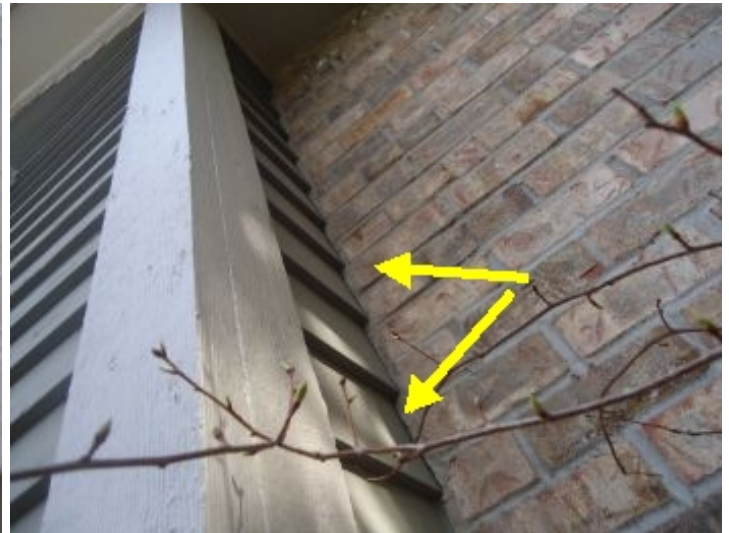
- Caulking cracked or gapped where masonry meets siding on bump-out on front of house.

add caulk

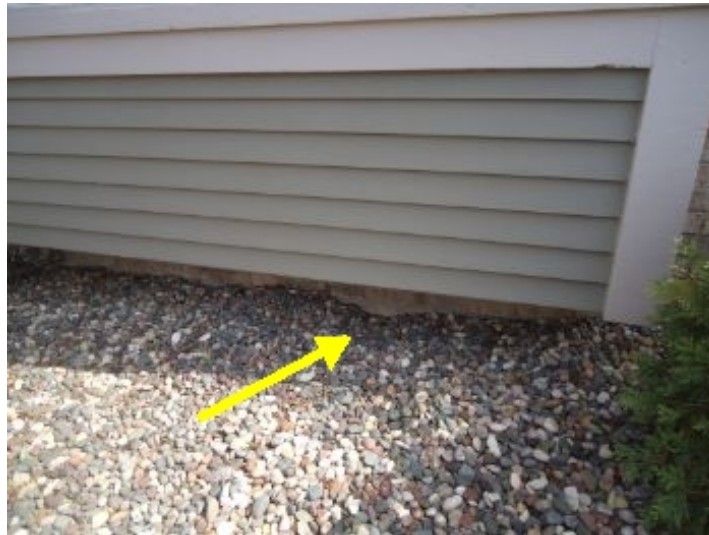
minor settling under bump out on front of house

- Recommend adding soil to area under bump out to maintain positive drainage away from house.

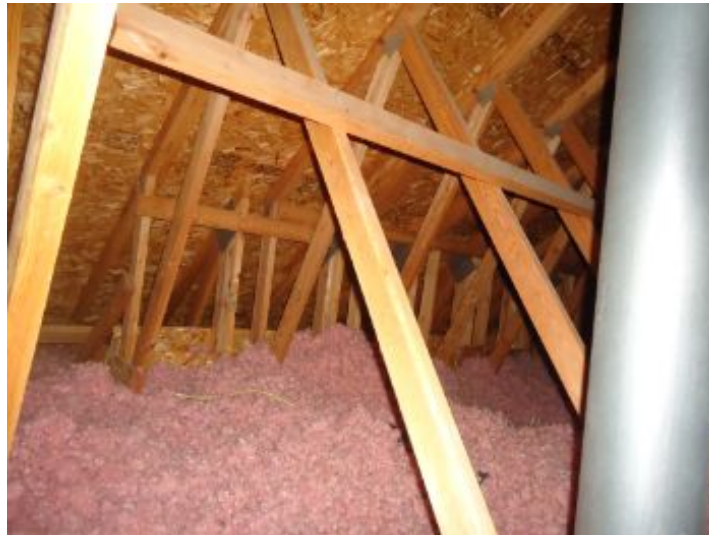
**Depth/R-Value:** none • Insulation depth varied greatly from 8" to 20". This is from being disturbed when service work is performed. Recommend blowing in additional insulation to bring R value to R-49.

**Observations:** Insulation that is settled does not perform to the R-Value that it once did.

insulation in attic uneven, recommend adding some

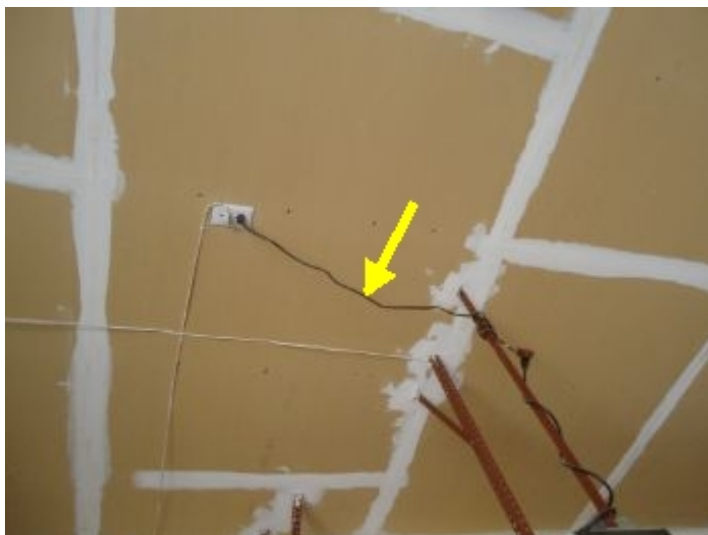
**Description:** Two automatic openers  
**Observations:**  
 • Appeared functional using normal controls, at time of inspection.  
 • Garage door openers should plug directly into outlet, not use an extension cord. Recommend moving outlet

garage door opener should not use extension cord

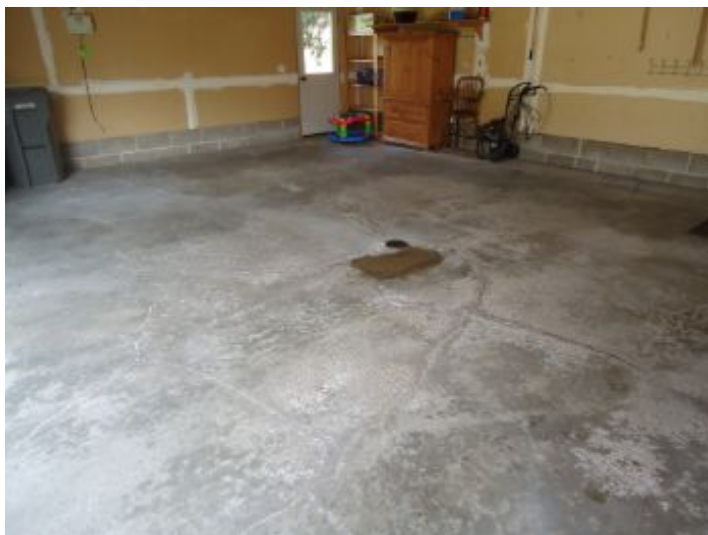
- Common typical cracks noted

normal, typical concrete cracking in garage floor

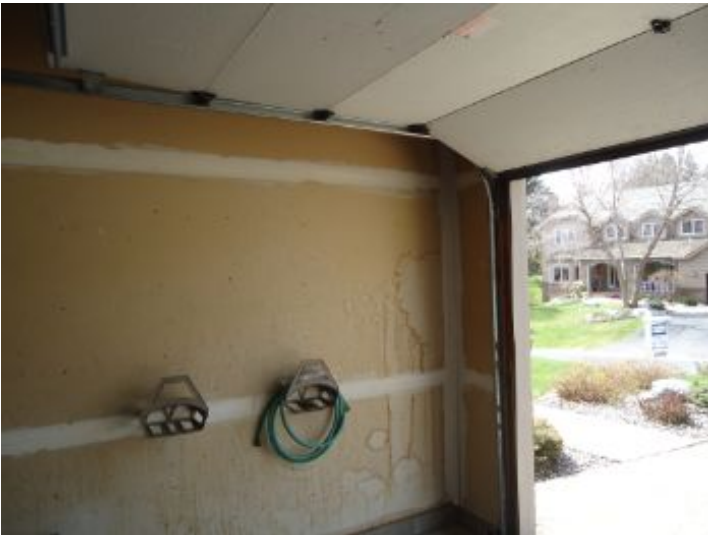
water stains on garage walls

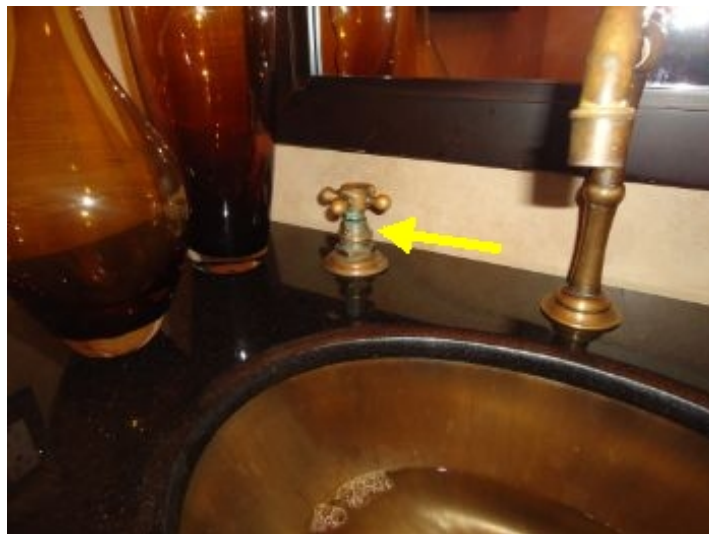
- No deficiencies noted with the exception of faucet in guest bathroom on 2nd floor the spout is loose.
- Green patina on faucet handle in half bath indicates it has leaked. Did not leak at time of inspection.

green patina indicates past leak, not presently active
